# INACTIVE AND ABANDONED MINE LANDS— Bodie Mine, Wauconda Mining District, Okanogan County, Washington

WASHINGTON  
DIVISION OF GEOLOGY  
AND EARTH RESOURCES  
Information Circular 106  
November 2007

# Inactive and Abandoned Mine Lands— Bodie Mine, Wauconda Mining District, Okanogan County, Washington

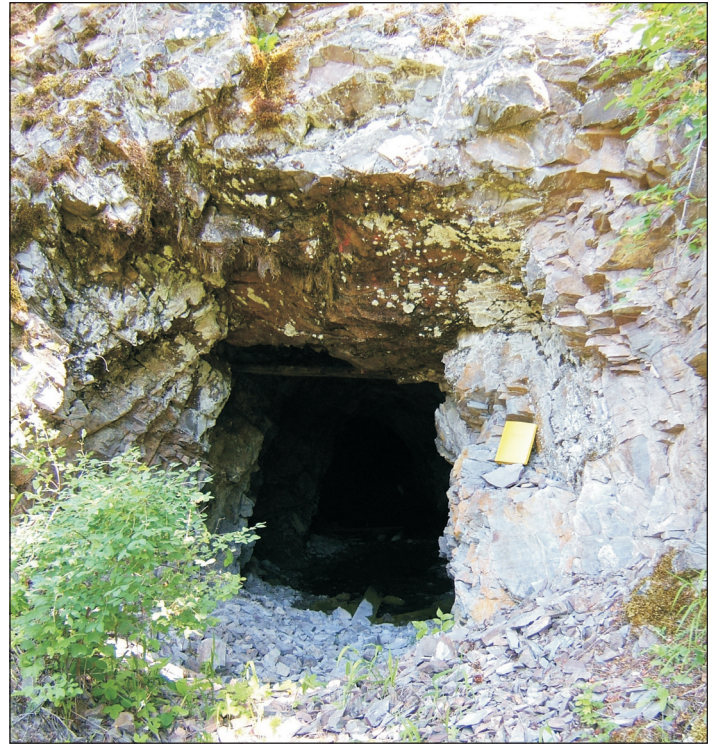
**Figure 2.** Massive andesite exposure at the 700-level portal. Platy fragments are spalling around opening. View is to the east.

Gold mineralization at the Bodie mine is remarkably similar to and of the same age as epithermal (50–200°C) hot-springs type gold deposits found at the First Thought mine in Stevens County and the Republic Mining District in Ferry County. Two host rocks, both in the upper Eocene Klondike Mountain Formation, surround the Bodie vein: a dense microcrystalline andesite flow grading to dacite in places, and one or more units of brecciated volcanic rock containing minor pyroclastic sediments. The andesite ranges in color from light green to dark purple and commonly displays a platy flow structure that dips into the hillside at moderate angles (Fig. 2).

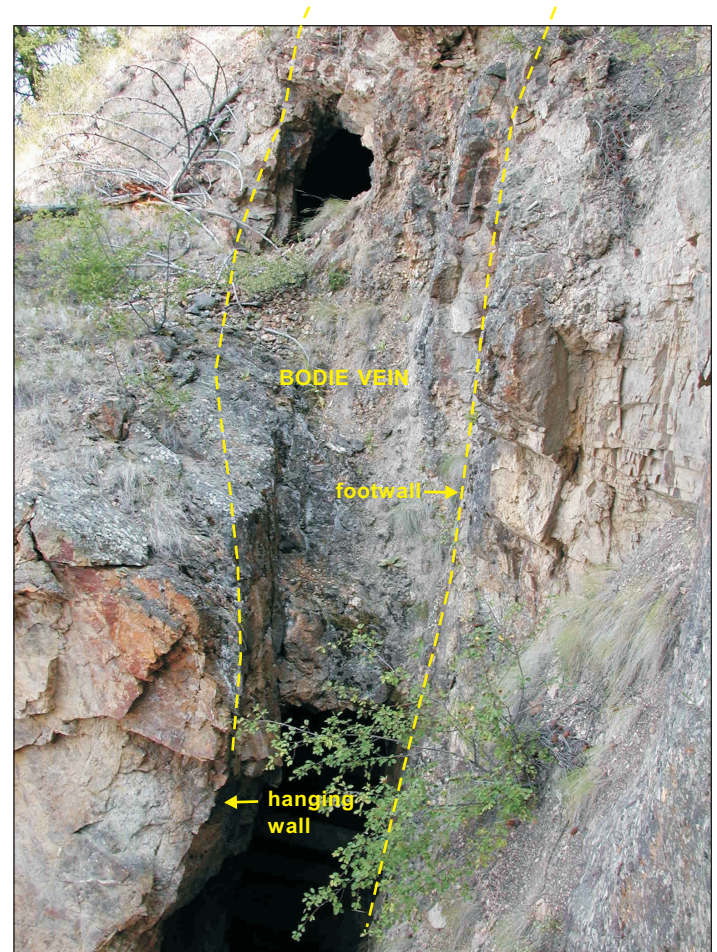
**Figure 3.** Bodie vein exposure and open stopes on the 100 level. View is to the north.

Although the brecciated rocks contain widespread gold mineralization as discussed below, historical mining operations have concentrated on a persistent vein up to 22 feet wide, striking N to N16°E and dipping 60 to 80°W. The Bodie vein contains a series of thin porcelain-like quartz stringers or veinlets separated by narrow bands of highly altered andesite and dacite as shown in (Fig. 3).

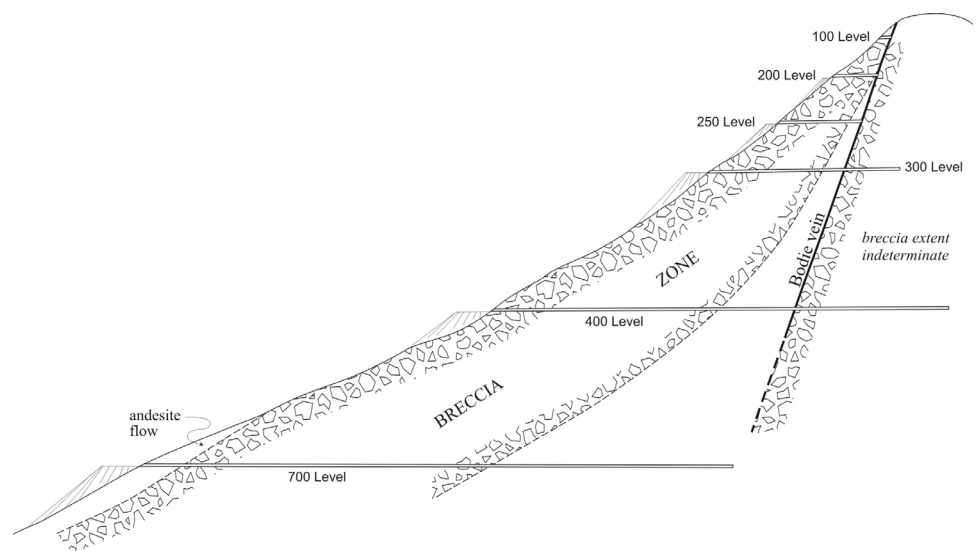
**Figure 4.** Cross section of the Bodie mine looking north. Levels are superimposed on one plane. (Modified from Moen, 1980.)

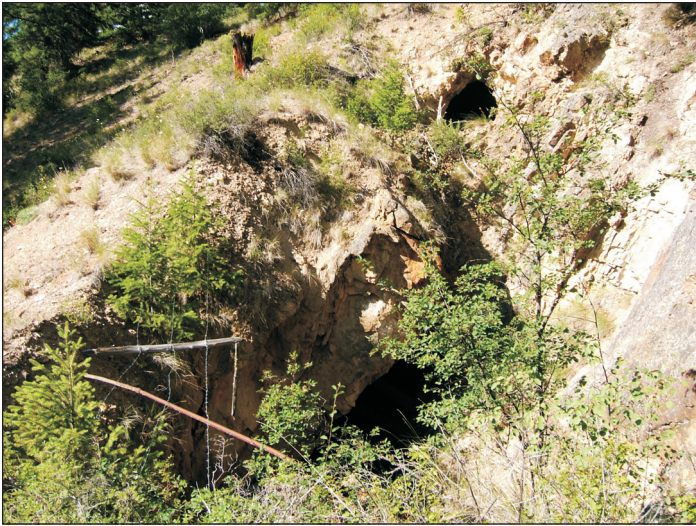
**Figure 7.** Open stopes along mine ridge. View is to the northeast.

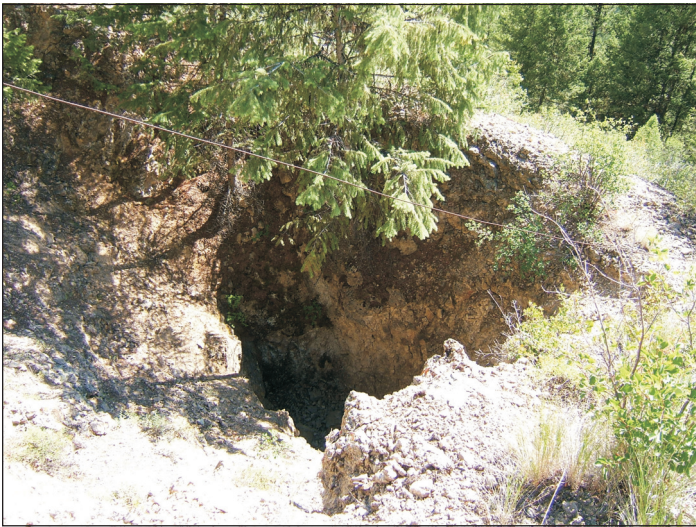
**Figure 9.** Glory hole, ~50 feet in diameter by 40 feet deep. The Bodie vein is 250 feet to the east. View is to the south.

A feature that resembles a glory hole is approximately 40 feet deep with vertical sidewalls (Fig. 9). It does not appear to be a subsidence feature. It is located 250 feet west of the northernmost open stopes. As such, it either represents a branching of the vein or a pocket of economic gold mineralization in the breccia.

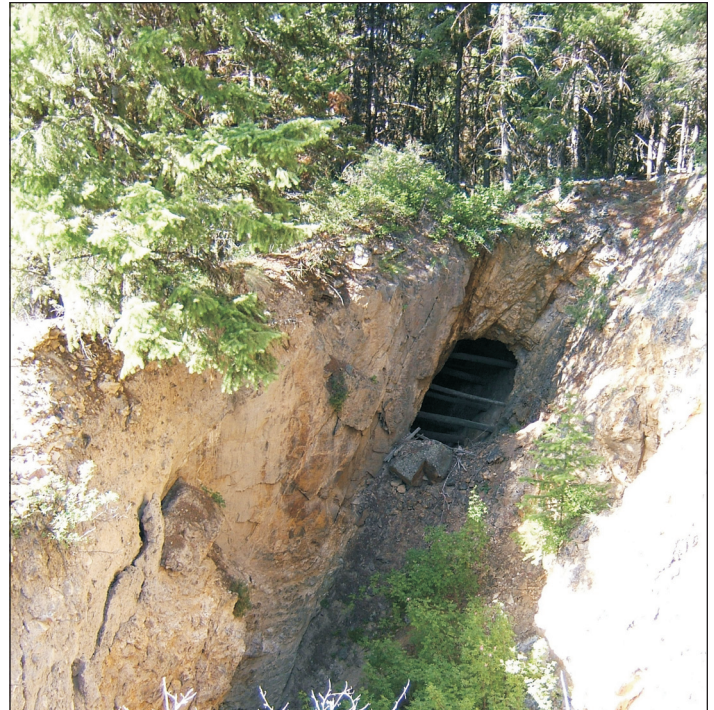
**Figure 8.** Open stopes along mine ridge. View is to the northeast.

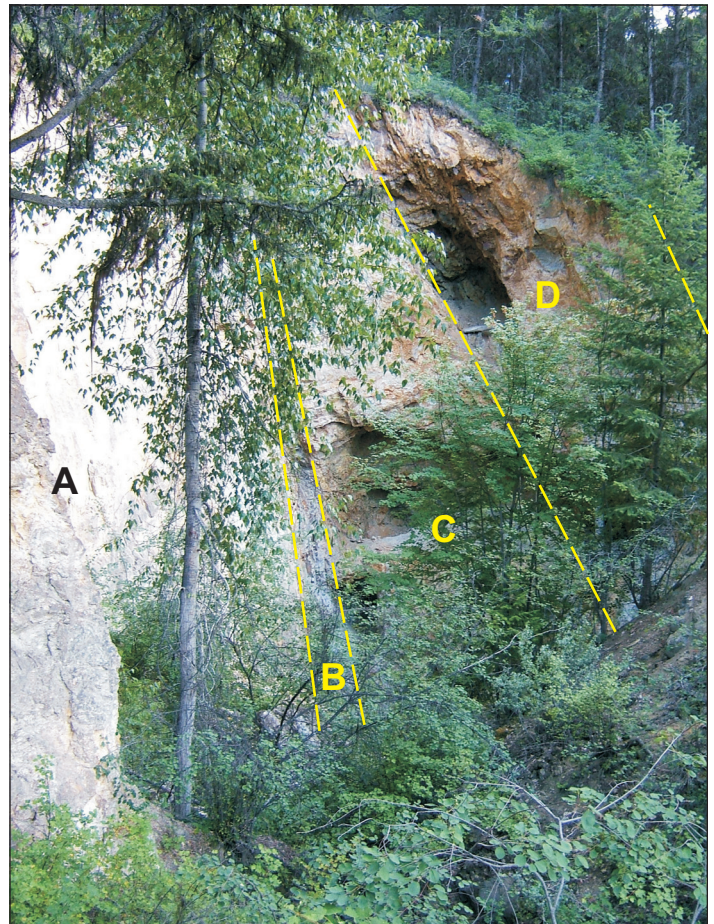
**Figure 10.** Different lithologies exposed in the open pit: A, fault plane or footwall; B, fault gouge (?); C, breccia unit (?); D, pyritized Bodie vein. View is to the south.

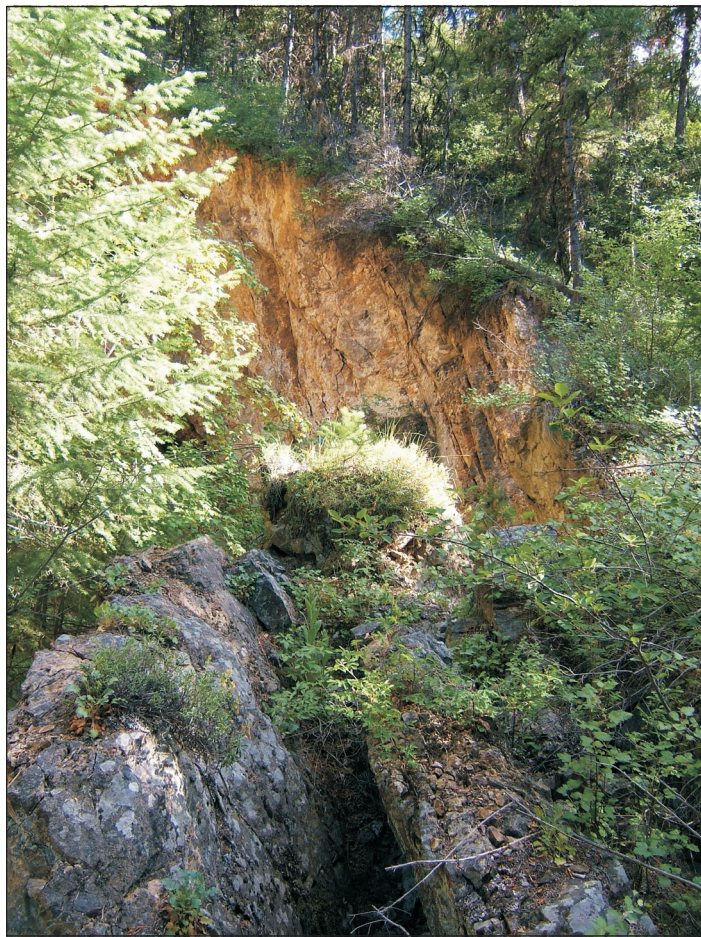
The headwall in an open pit located on strike ~250 feet southeast of the 300-level portal is about 100 feet in height with several adits and at least one raise entering the sidewalls (Fig. 10). The area could not be safely entered. The vein's hanging wall at the pit location is separating and falling into the opening, and caved beneath it during DGER site characterization (Fig. 11).

**Figure 11.** Ten-foot-deep cracks in the open pit hanging wall. Material is collapsing into the pit. View is to the south.

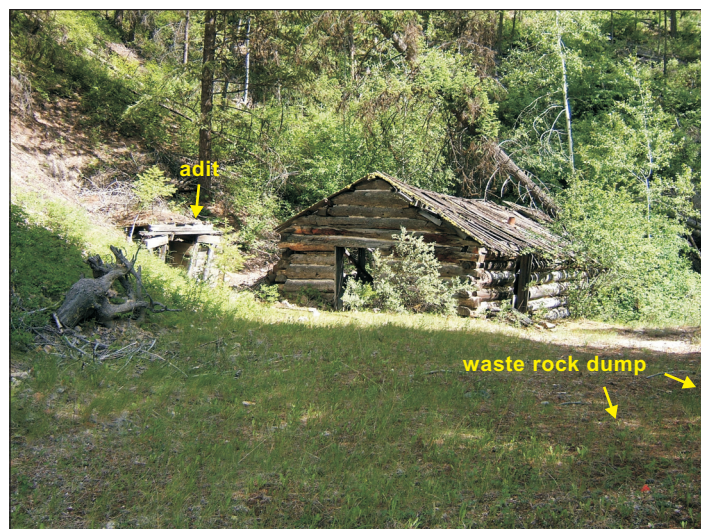
The log structure on the 400-level dump is a maintenance shop (Fig. 12). It contains vestiges of a bit-sharpening forge and a circa-1930s drilling equipment. A frame building, probably an office or on-site residence, is located on a bench several hundred feet south of the mill footings. In the late 1930s, ore was transported via aerial tramway from the 400-level portal to the mill. The cables still span part of the distance, but the tail- and headworks are collapsed.

**Figure 12.** 400 level adit, waste rock dump, and shop. View is to the east.

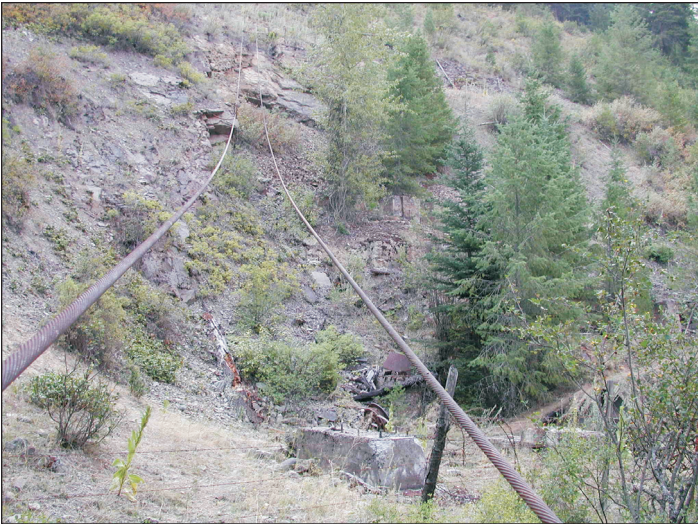
The mill site is marked by the presence of crusher and ball mill foundations, but the mill burned in 1962 (Fig. 13). A photo taken in 1936 by Chamberlain shows the Northern Gold mill site, tramway, and ore bin (Appendix F, Fig. F3). The original ore mined in the 1890s was sufficiently high-grade to be direct shipped to a smelter. In 1902, Bodie Mining Co. installed a ten-stamp 20 tpd mill using mercury amalgamation and cyanidation. Precious metal recovery was poor considering the relatively high assays of the run-of-mine ore, resulting in the property changing hands several times until operations stopped altogether in 1916 (DGER mine file).

**Figure 13.** Mill site footing and tram cable to the 400-level adit. View is to the east.

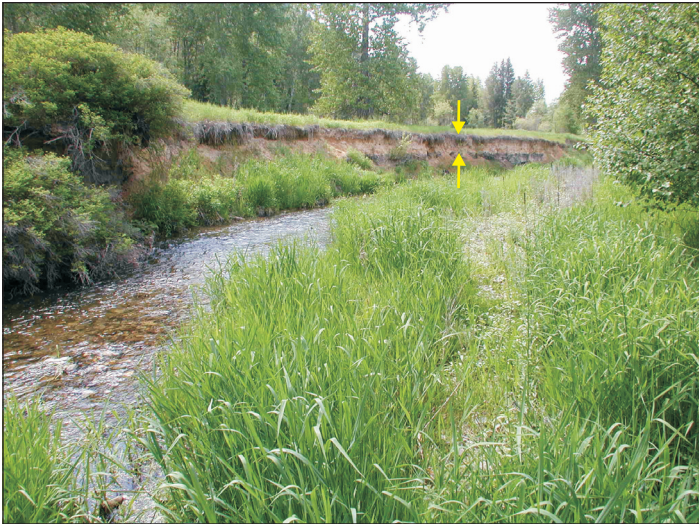
The tailings are exposed for 1500 feet along a cut bank on the east margin of Toroda Creek. They cover an area of 6.5 acres, 4 feet thick on the margins and about 8 feet thick closer to the mill site. Cottonwood trees up to 20 inches in diameter and a thick stand of grass have established on the surface (Fig. 14). The total volume is in the range of 30,000 to 40,000 cubic yards at a density of 1.65 tons per cubic yard.

**Figure 14.** Cut bank on Toroda Creek. Light brown tailings (between arrows) overlie the original land surface. Flow is right to left. View is to the south.

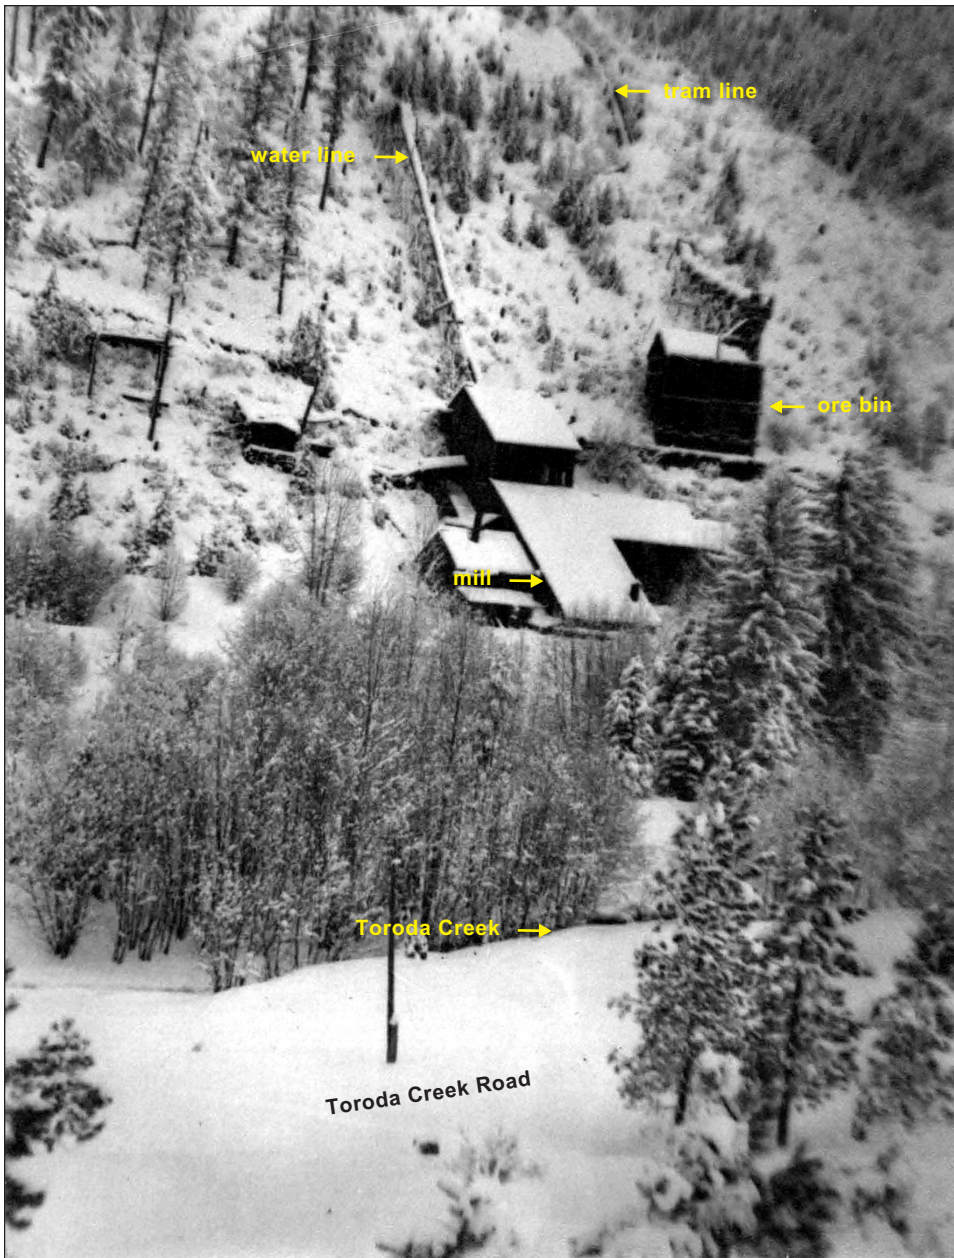
**Figure F3.** Mine site circa-1936 (after Chamberlain, 1936). View is to the east.
